Overhills: Entrance Compound

Historic Building Survey

January 2009

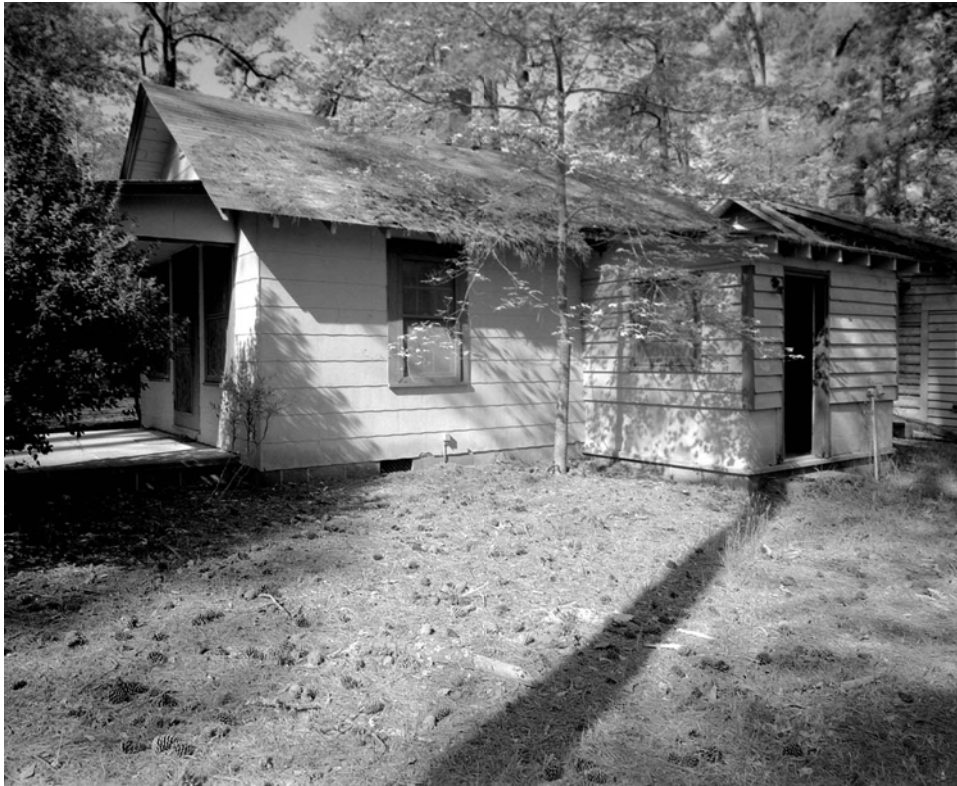
HABS No. NC-407-E-9

**NC-407-E-9 NORTHEAST FAÇADE OF LAUNDRY ROOM; VIEW TO
NORTHWEST**

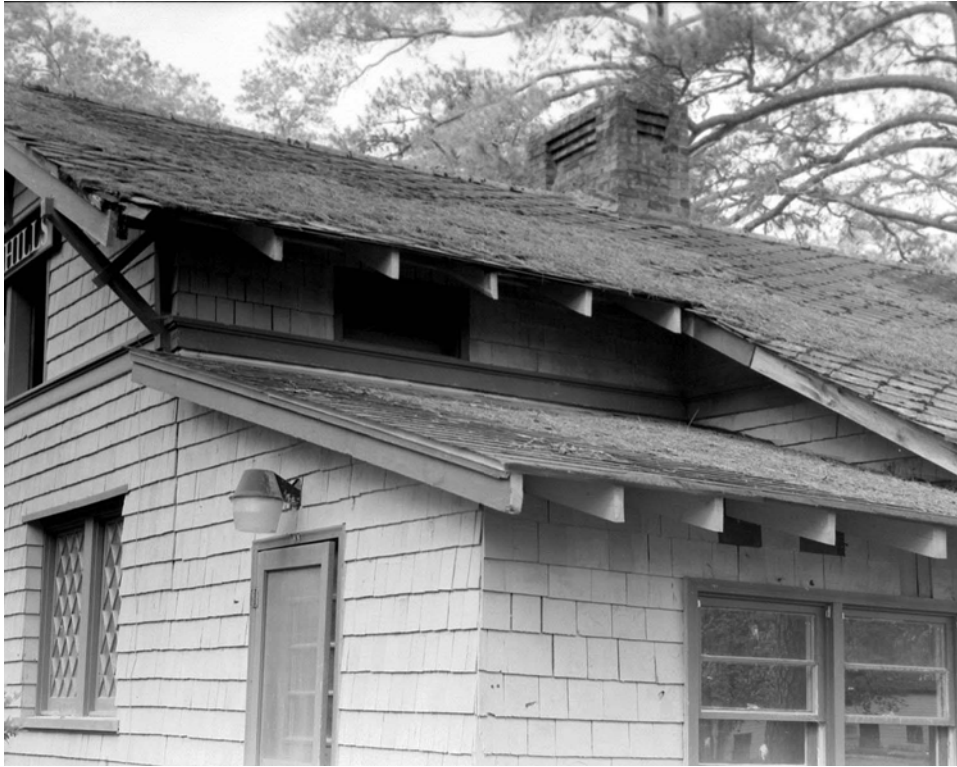
HABS No. NC-407-F-8

**NC-407-F-8 DETAIL, EAST CORNER SHOWING UPPER SLIT WINDOW
UNDER EAVES AND EAST SHED ADDITION; VIEW TO WEST**

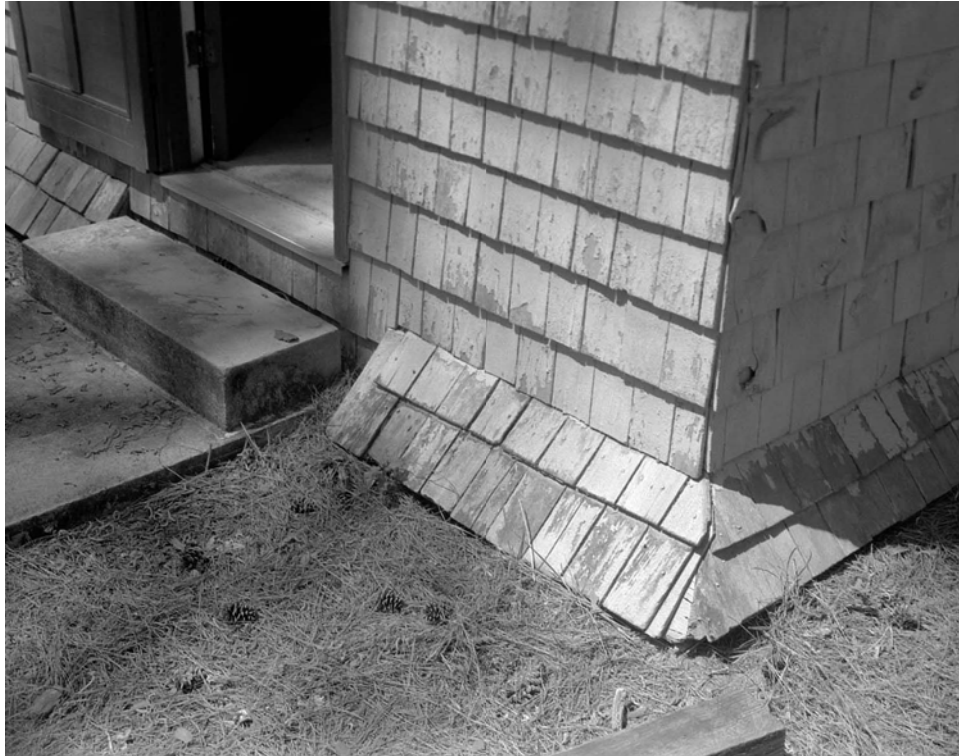
HABS No. NC-407-F-9

**NC-407-F-9 DETAIL, FOUNDATION SKIRT AT EAST CORNER SHED
ADDITION; VIEW TO WEST**

2. Foundations: The foundation is covered by a wood shingle skirt (Photo NC-407-F-9) and is therefore undetermined.
3. Wall Construction: The main perimeter walls have a wood shingle finish with 5½" to 5¾" tall shingles. Member sizes of the frame are undetermined.

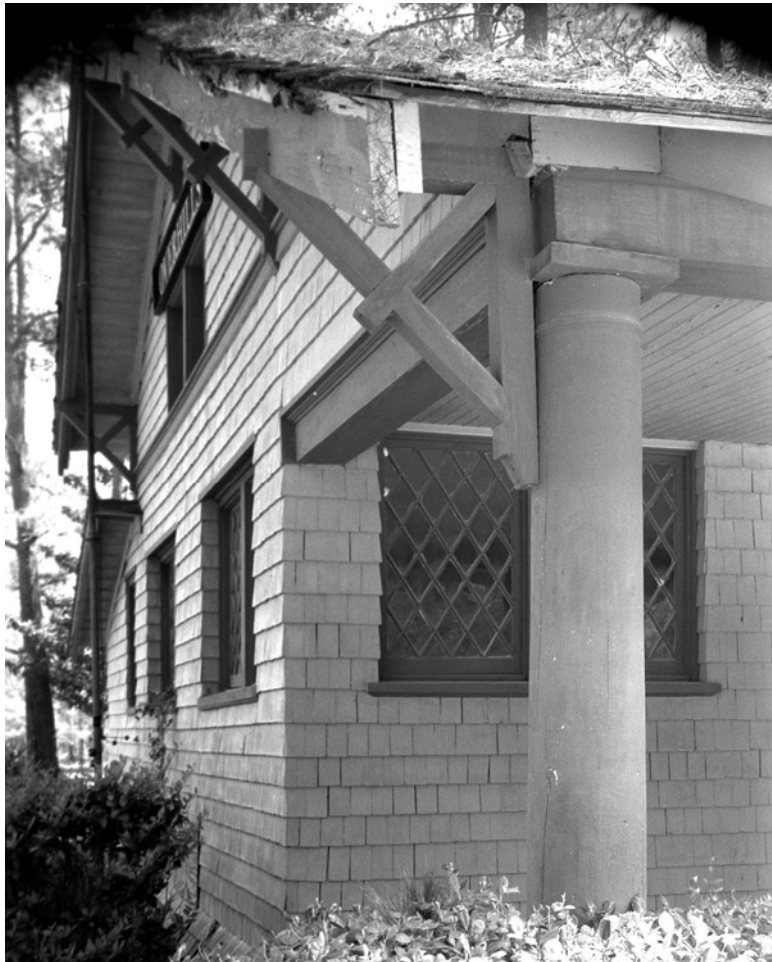
HABS No. NC-407-F-10

**NC-407-F-10 DETAIL, WEST FRONT PORCH CORNER
SHOWING TYPICAL BRACKET; VIEW TO NORTHEAST**

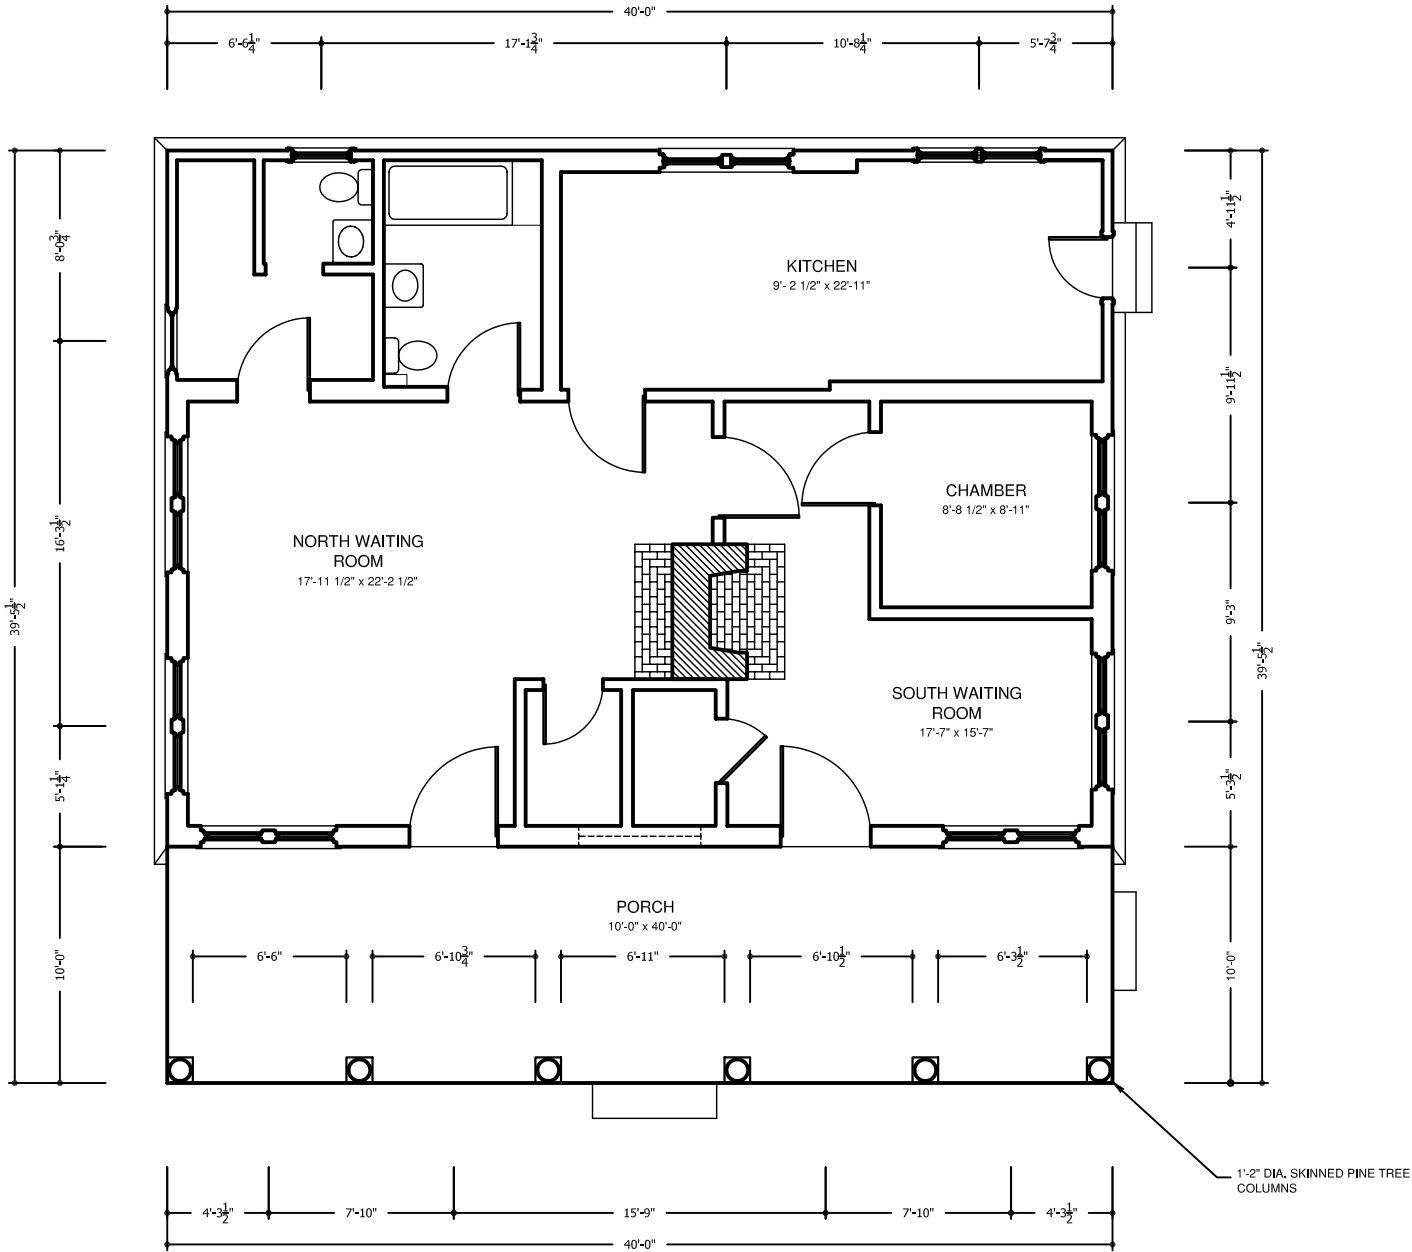
WEST ELEVATION

NOTE: DOTTED LINE ON PORCH WALL DEPICTS LOCATION OF AN ORIGINAL WINDOW OPENING
DIAMOND PANE WINDOWS NOT OPERABLE

MATERIALS
SIDING: 5 1/2" TO 5 3/4" WOOD SHINGLES
ROOF: MAIN ROOF -- ASBESTOS-CEMENT SHINGLES IN A HONEYCOMB PATTERN
CHIMNEY: COMMON BRICK

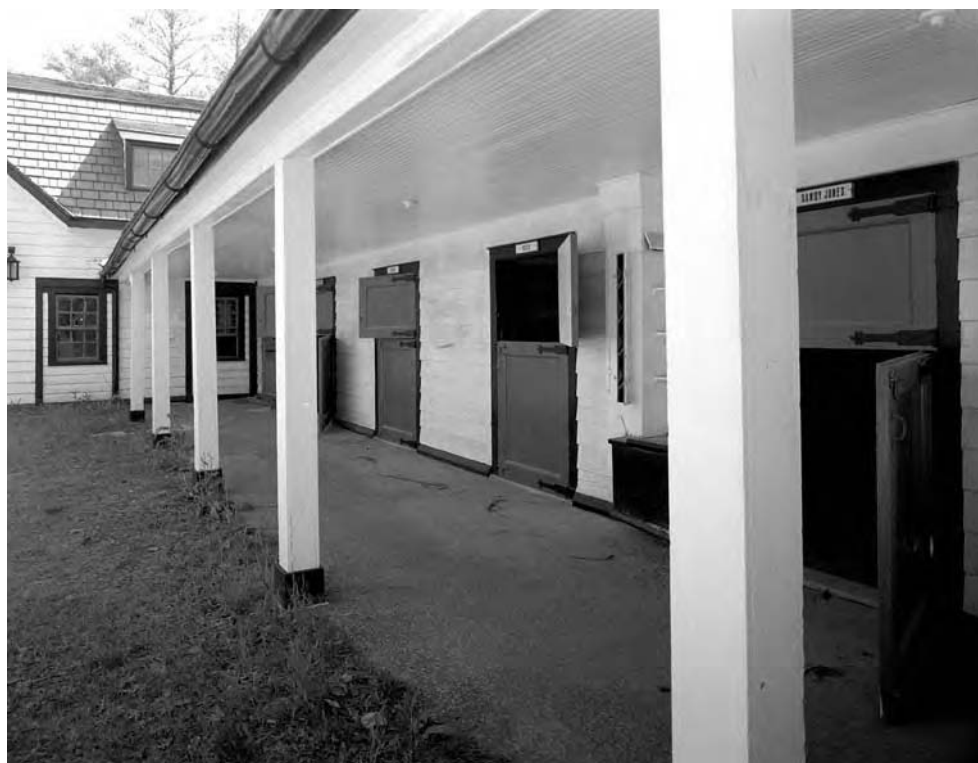
HISTORIC AMERICAN BUILDINGS SURVEY
SEE INDEX TO PHOTOGRAPHS FOR CAPTION
HABS No. NC-407-H-6

**NC-407-H-6 NORTHWEST ELEVATION OF SOUTHEAST STABLE BLOCK
COVERED ACCESS TO STALL DOORS; VIEW TO NORTHEAST**

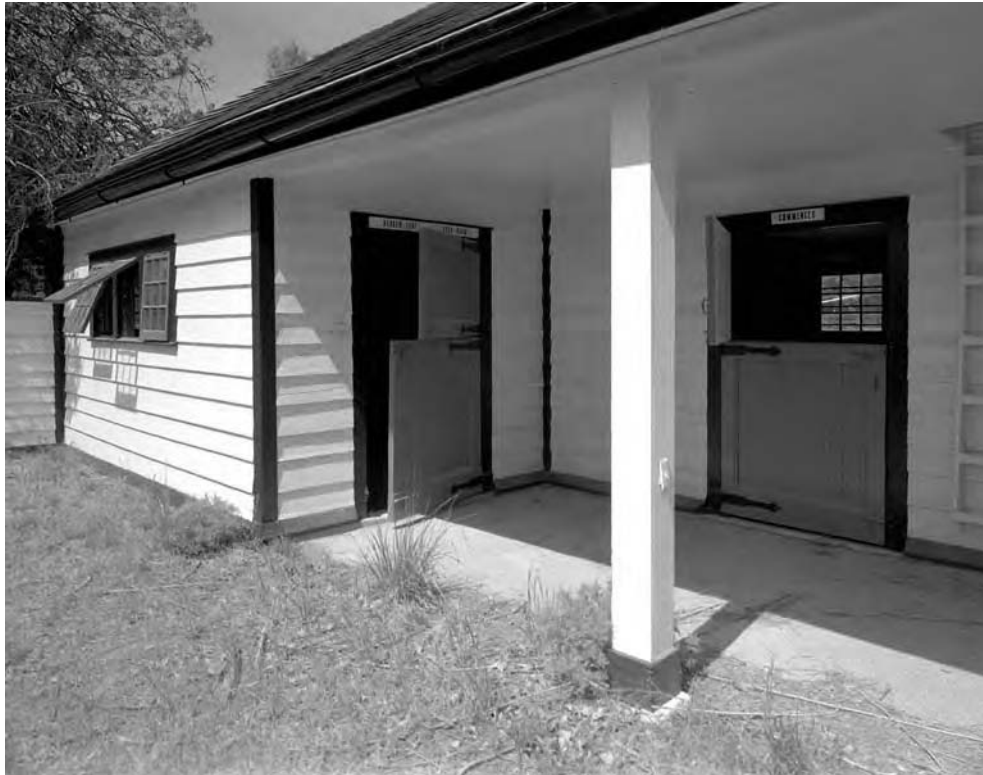
HABS No. NC-407-H-7

**NC-407-H-7 NORTHWEST WING DETAIL SHOWING PROJECTING
ENCLOSURE AT SOUTH END OF STRUCTURE, WITH TYPICAL ‘DUTCH’
OUT-SWINGING STALL DOORS, VIEW TO SOUTHWEST**

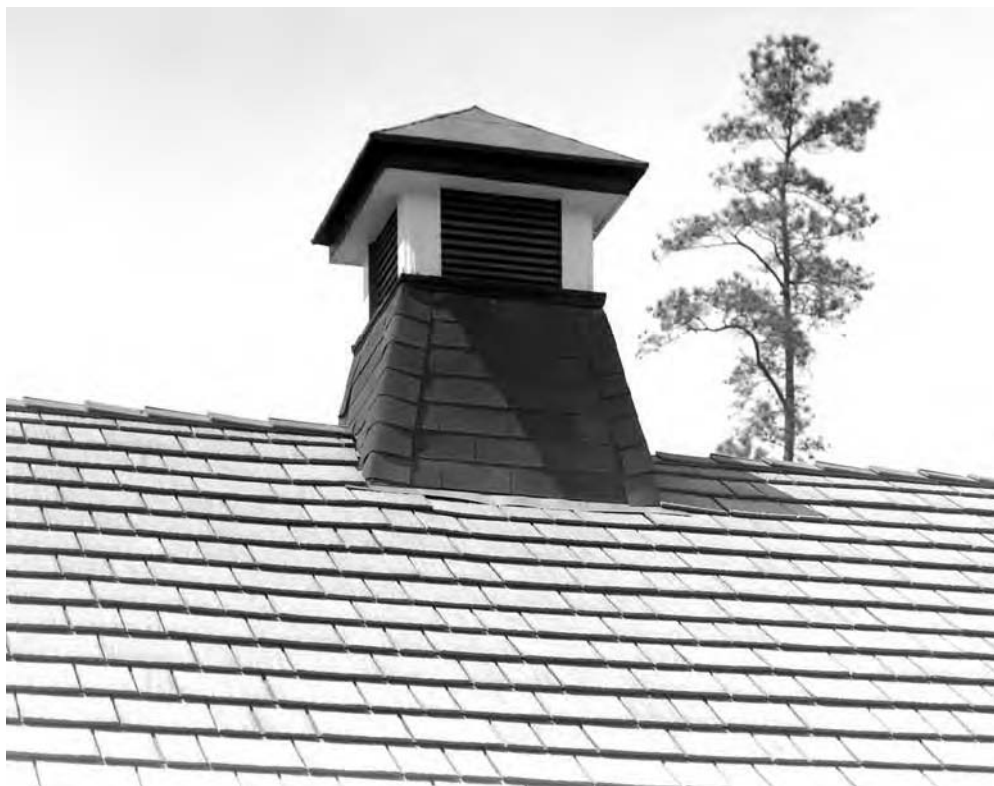
HISTORIC AMERICAN BUILDINGS SURVEY
SEE INDEX TO PHOTOGRAPHS FOR CAPTION
HABS No. NC-407-H-10

**NC-407-H-10 DETAIL, ROOF VENT, NORTHWEST WING, VIEW TO NORTH
FROM INSIDE COURTYARD**

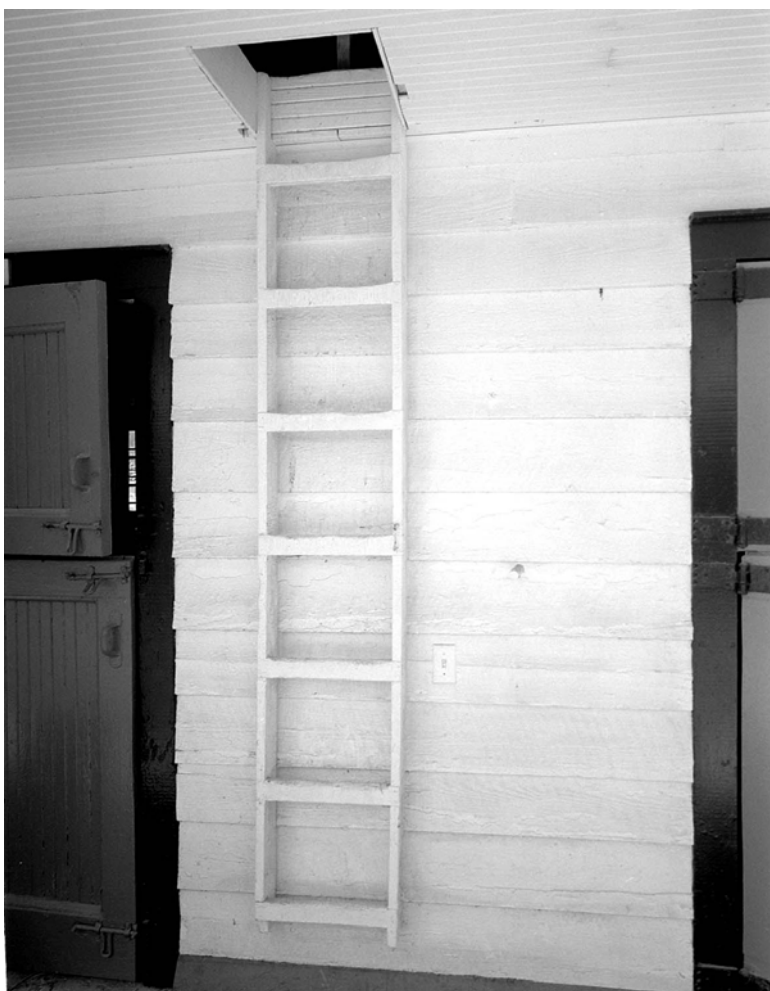
HISTORIC AMERICAN BUILDINGS SURVEY
SEE INDEX TO PHOTOGRAPHS FOR CAPTION
HABS No. NC-407-H-11

NC-407-H-11 DETAIL, wall-mounted ladder from grade level at stall doors leading up to hay loft, view of northwest wing, to West

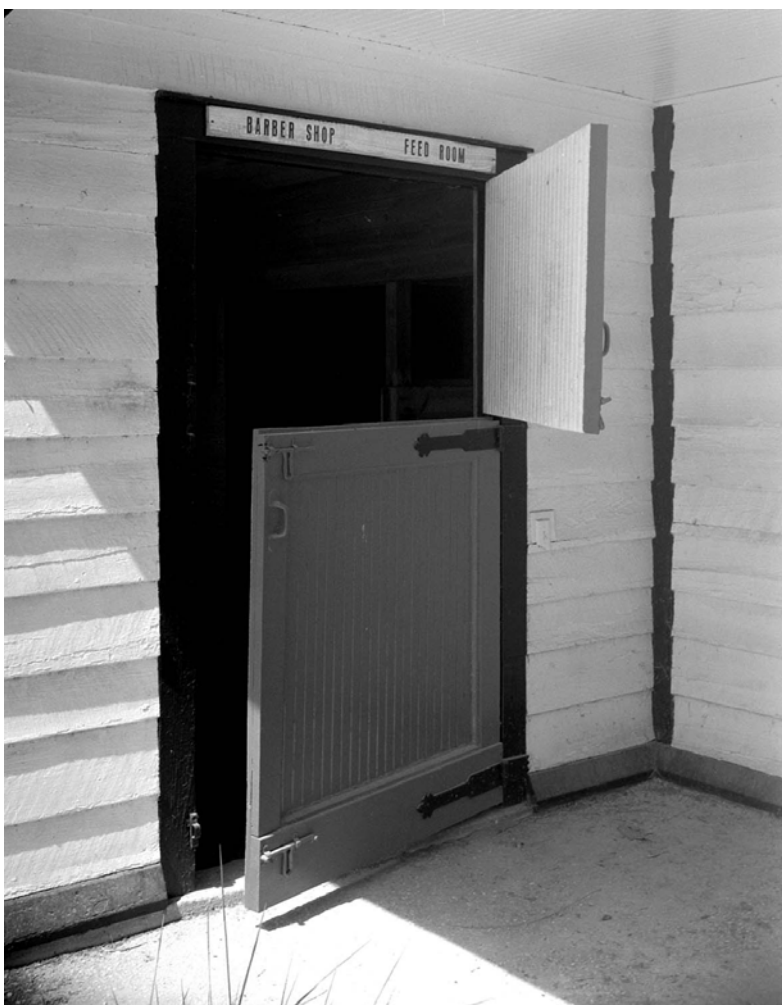
HISTORIC AMERICAN BUILDINGS SURVEY
SEE INDEX TO PHOTOGRAPHS FOR CAPTION
HABS No. NC-407-H-12

**NC-407-H-12 DETAIL, TYPICAL STABLE STALL DOOR
(NOTE INTERIOR IS PAINTED WHITE, TO AID IN
ILLUMINATING DARK INTERIOR STALL), VIEW (OF NO.7)
TO WEST**

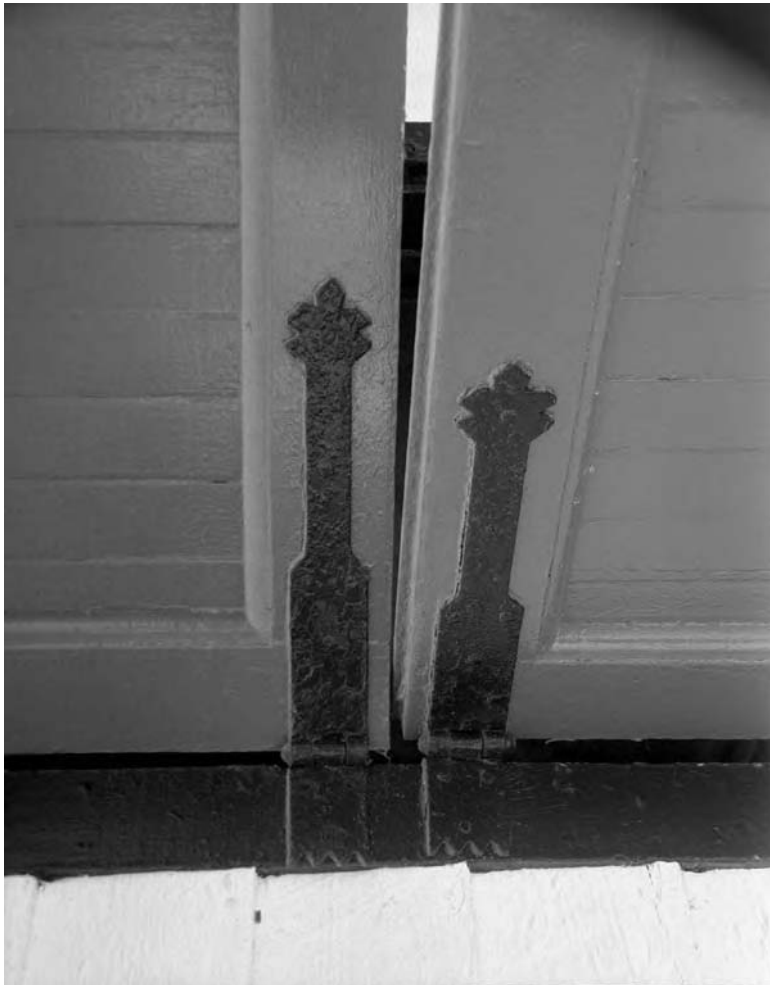
HABS No. NC-407-H-13

**NC-407-H-13 DETAIL, TYPICAL INTACT PAINTED HINGE
SET AT STALL DOOR, VIEW OF NORTHWEST WING, TO
NORTHWEST**

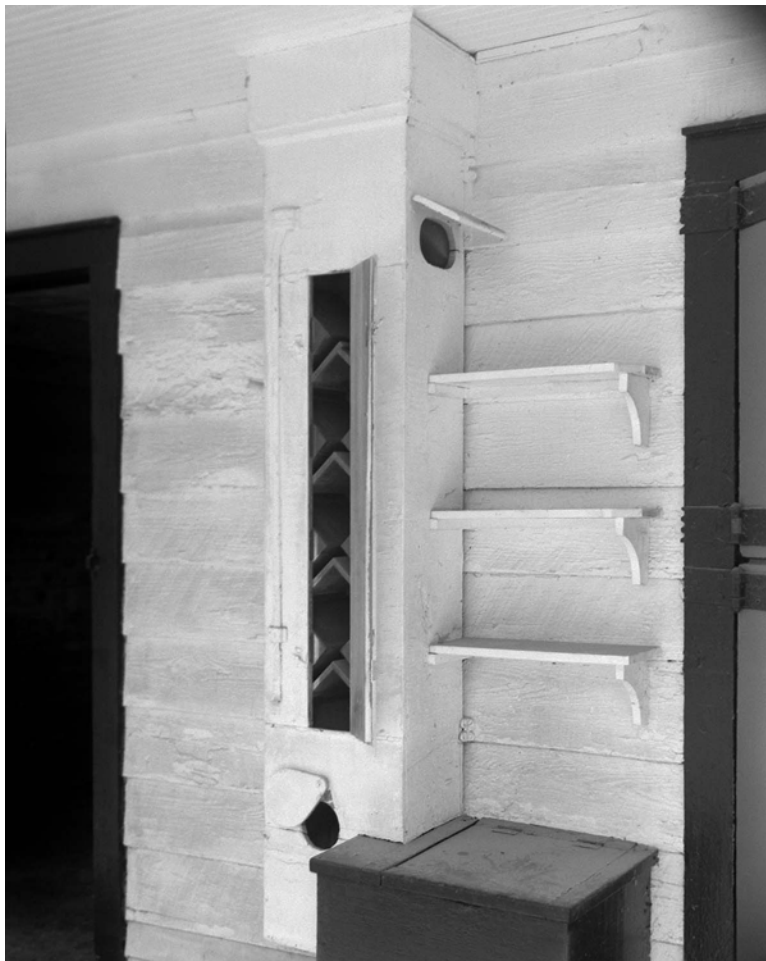
HABS No. NC-407-H-14

**NC-407-H-14 DETAIL, WALL WITH OAT-SORTER INTACT,
VIEW OF WEST WALL TO WEST**

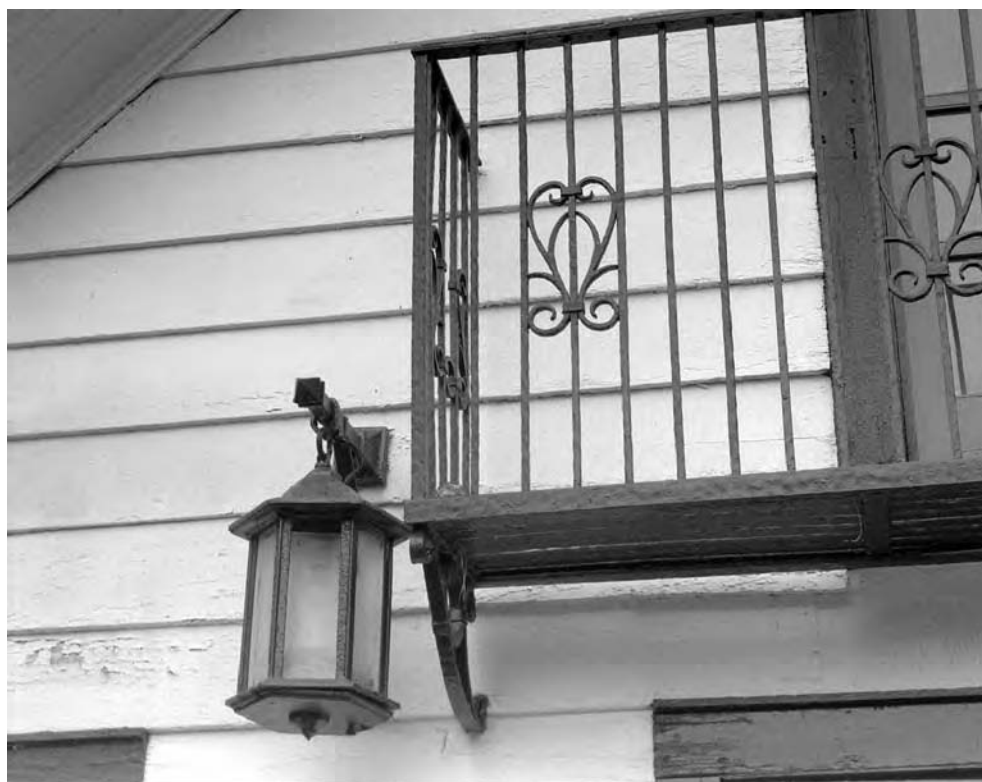
HISTORIC AMERICAN BUILDINGS SURVEY
SEE INDEX TO PHOTOGRAPHS FOR CAPTION
HABS No. NC-407-H-15

**NC-407-H-15 DETAIL, ORNAMENTAL LANTERN AND BALCONY CENTRAL
TO COURTYARD AXIS (SEE NO.3), VIEW TO NORTHEAST**

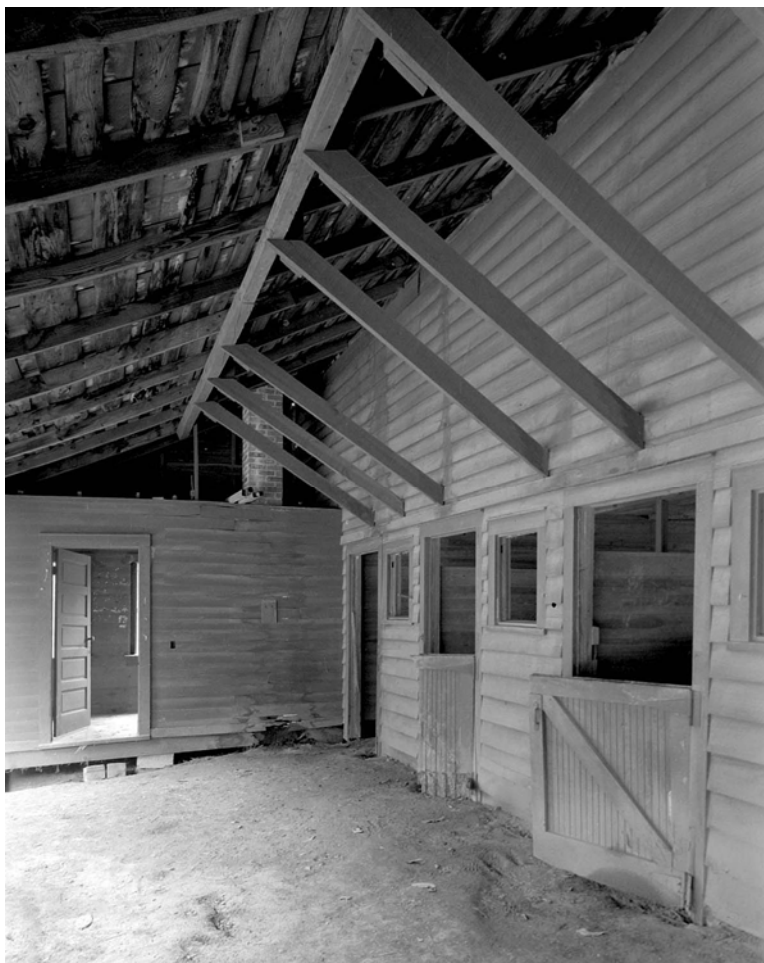
HABS No. NC-407-K-8

**NC-407-K-8 DETAIL, COVERED NORTHWEST SIDE STALL
AREA; VIEW TO NORTHEAST**

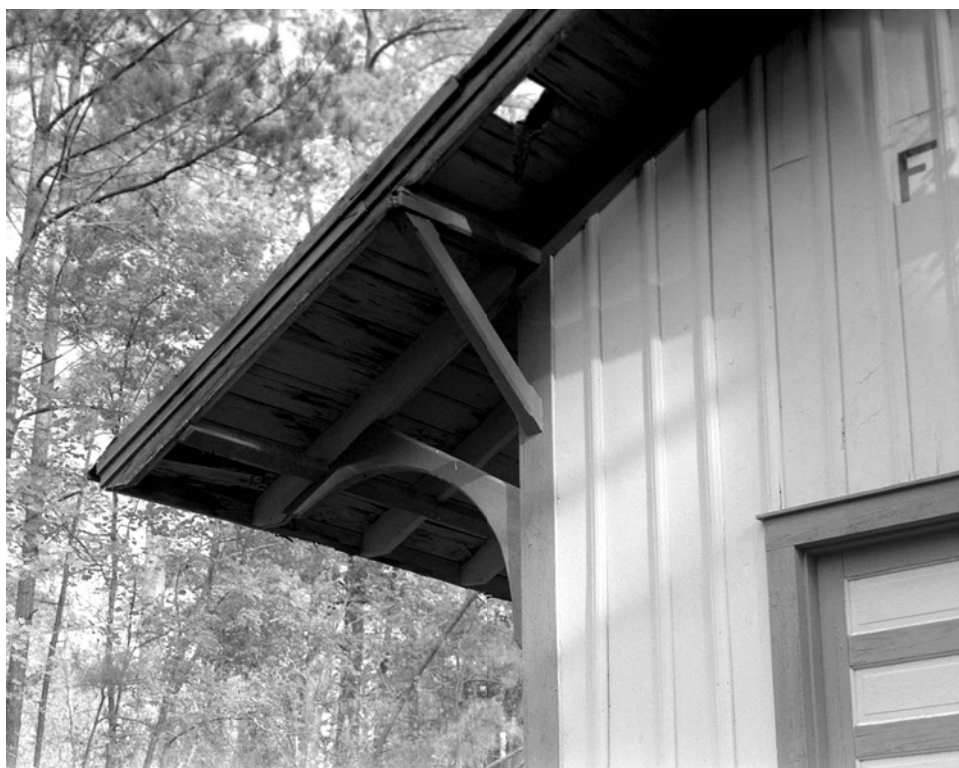
HISTORIC AMERICAN BUILDINGS SURVEY
SEE INDEX TO PHOTOGRAPHS FOR CAPTION
HABS No. NC-407-M-7

**NC-407-M-7DETAIL, ROOF BRACKETS, SOUTHEAST CORNER; VIEW TO
NORTH**

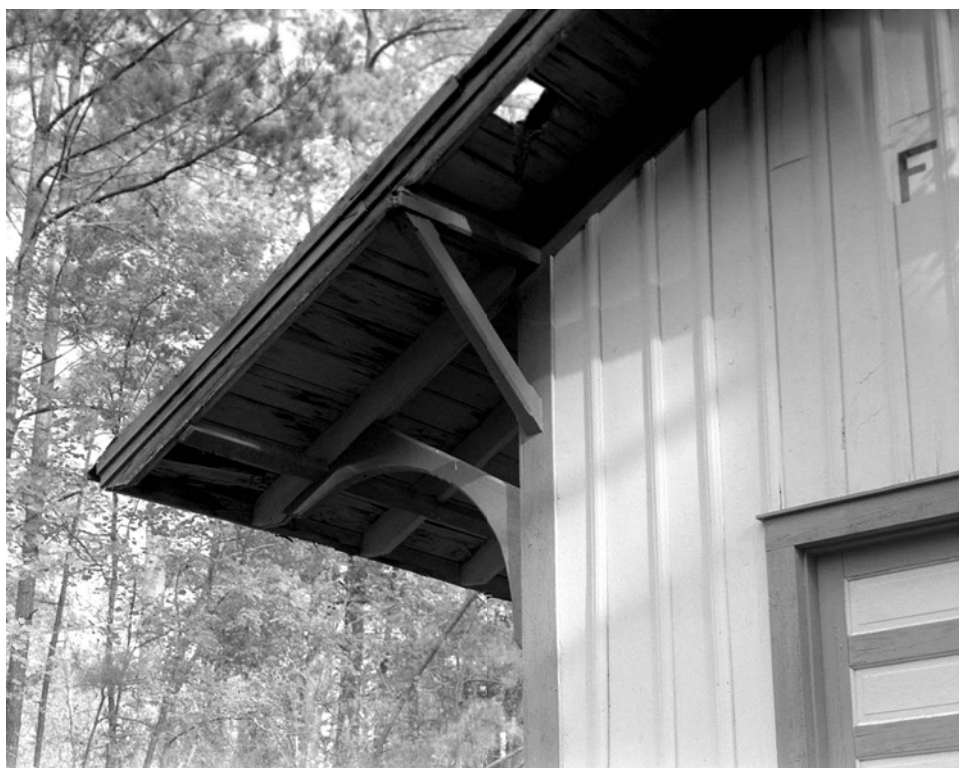
HISTORIC AMERICAN BUILDINGS SURVEY
SEE INDEX TO PHOTOGRAPHS FOR CAPTION
HABS No. NC-407-M-7

**NC-407-M-7DETAIL, ROOF BRACKETS, SOUTHEAST CORNER; VIEW TO
NORTH**
